### OAKLAND UNIVERSITY MEADOW BROOK ROAD CULVERT REPAIR

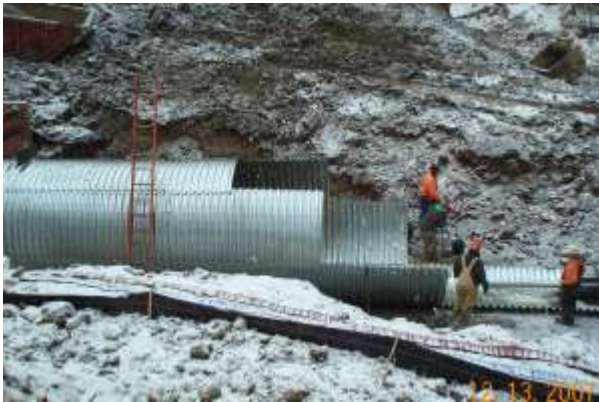
**Plate Pipe Replacement**

J&A expedited an investigation and developed a repair strategy that has returned the culvert to its prior condition. The repair strategy involved closure of the roads, removal of the damaged plates, and

installation of new plates and construction of protection measures on the upstream end of the culvert. J&A staff performed contract administration and site inspection for project.

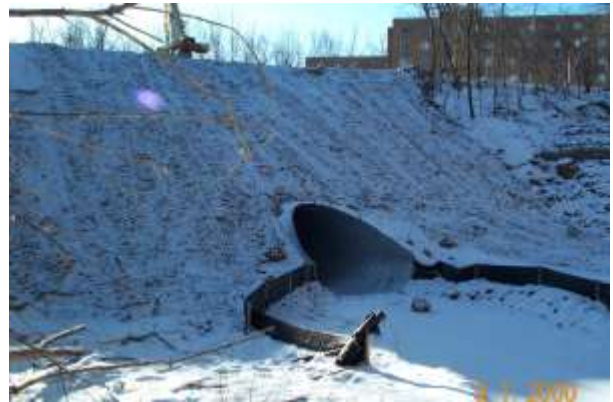
**Embankment Constructed**
